State and Performance of Water Retention Structures of Earthen Irrigation Dams in Northern Ghana

ABSTRACT

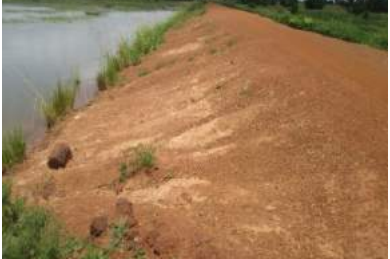
Golonga

<ul style="list-style-type: none"> i. The embankment is 700 m long with a maximum height of 5.0 m. ii. The upstream and downstream slopes are eroded as no riprapping and vegetative cover respectively on the upstream slope and downstream slope. iii. There are potholes at some sections of the crest and erosion has reduced the height of the dam wall. iv. The embankment had some structural defects although it was rehabilitated in the year 2012.

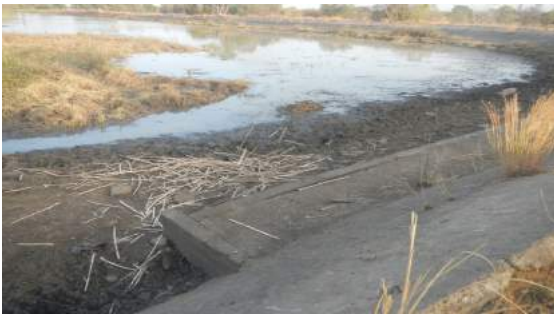
Plate 1: Silted and Weedy Night Storage Reservoir 1 in Tono

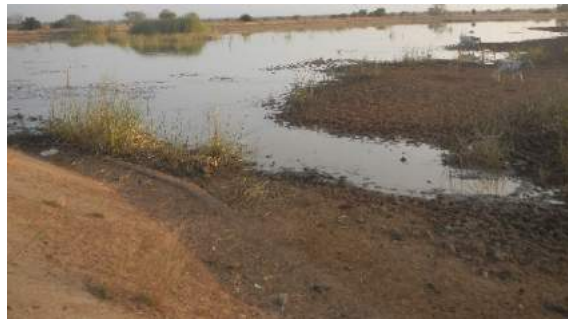
Plate 2: Silted and Weedy Night Storage Reservoir 2 in Tono

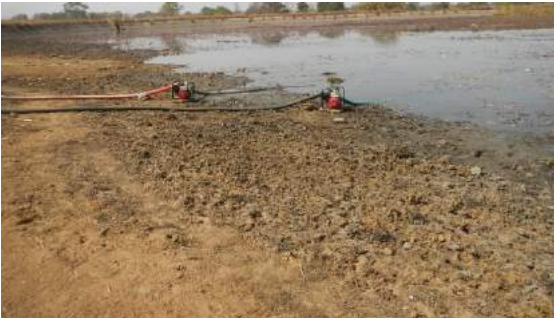
Plate 3: Silted Night Storage Reservoir 3 in Tono

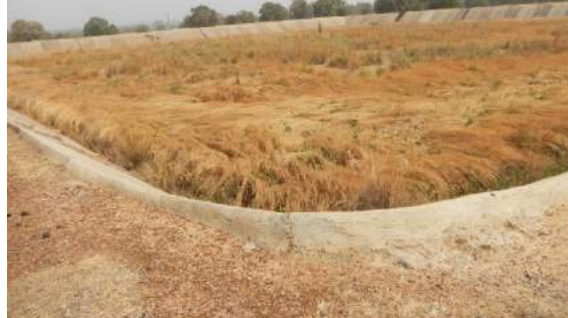
Plate 4: Weedy Night Storage Reservoir 4 in Tono

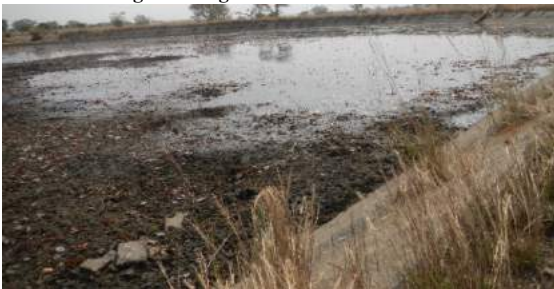
Plate 5: Silted Night Storage Reservoir 5 in Tono

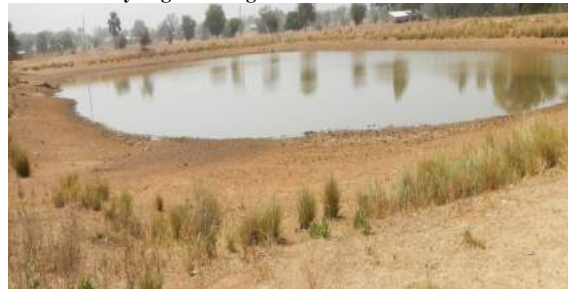
Out of the eight (8) irrigation schemes, Tono and Vea schemes were the only irrigation schemes with night storage reservoirs. These structures were constructed at strategic locations downstream of the schemes. The Tono irrigation scheme has seven (7) night storage reservoirs and all were rehabilitated in 2008. However, as of 2017, all the reservoirs were in very poor condition. They were silted and weedy as illustrated in Plates 1 to 5. The Vea irrigation scheme has one (1) night storage reservoir (Plate 6) and this had not been in use since 1997 due to broken inlet and outlet canals, valves and siltation.

Plate 6: Silted Night Storage Reservoir in Vea Scheme
