Performance of Irrigation Water Delivery Structures in Six Schemes of Northern Ghana

Abstract

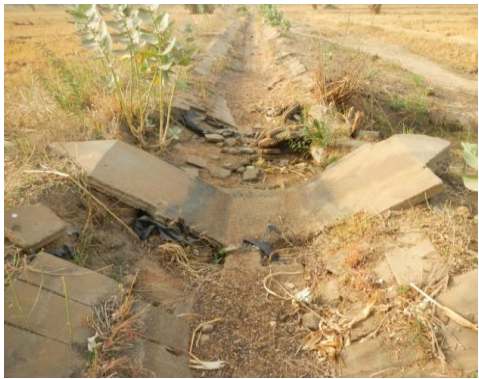
Tono Irrigation Scheme: The scheme recorded PSI of 46 % which strongly reveals that the conditions of the structures of the scheme are in very poor working condition when compared to the recommended value (0 %) as given by [14]. The conveyance structures that are in a very poor condition are the laterals. The scheme has 82 laterals of which 75 are severely breached; all the

Plate 1: Conditions of Laterals in Tono Irrigation Scheme

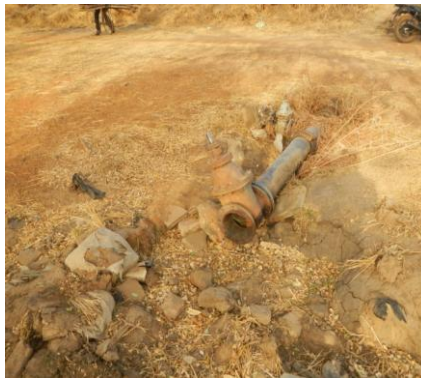
Plate 2: Exposed and Broken Lateral Pipes in Tono Scheme

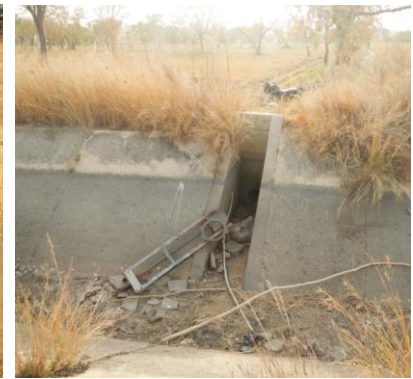
concrete slabs and linings are removed (Plate 1). The buried lateral pipes are also exposed and broken (Plate 2). The regulatory structures that are in poor working condition are the lateral gates. A total of 93 lateral gates were installed on the right and left bank canals of which 15 are not functioning due to detached stem from plates and worn out angle-iron (Plate 3).

Plate 3: Broken Lateral Gates in Tono Irrigation Scheme

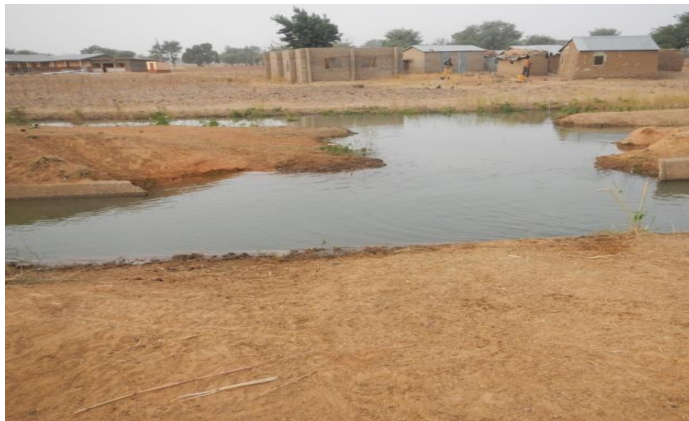
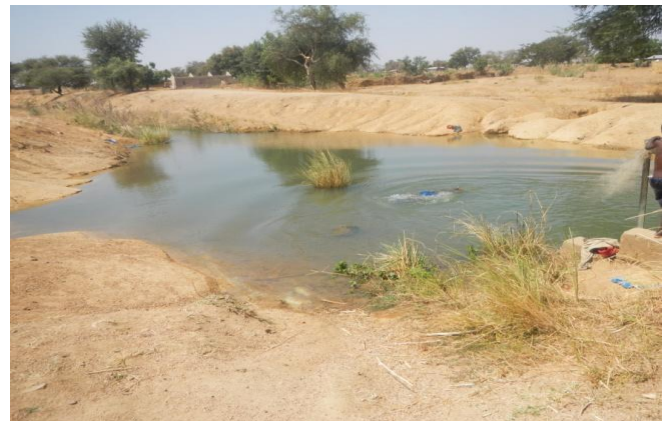
Vea Irrigation Scheme: The scheme recorded 87 % poor structure index, which clearly indicates the conveyance, regulatory and flow measuring structures of the scheme are in poor condition. The two main canals are weedy, silted and severely breached at several sections (Plate 4), 4 out of the 5 off-take valves are defunct, all the 60 concrete lined laterals are broken, and 54 out of the 70 lateral gates are broken. Farmers find it very difficult to

Plate 4: Conditions of Main Canals in Vea Irrigation Scheme

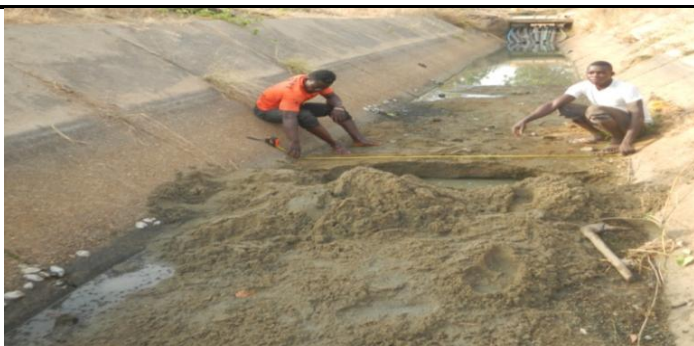
<ol style="list-style-type: none"> 1. The 42 km long main canals have no breaches 2. It was rehabilitated in 2008, where the two (2) canals were relined with concrete 3. The canals have not been desilted since 2012. The average sediments depth was estimated to be 0.32 m 4. Estimated average volume of sediments was 17,220 m³
Veal

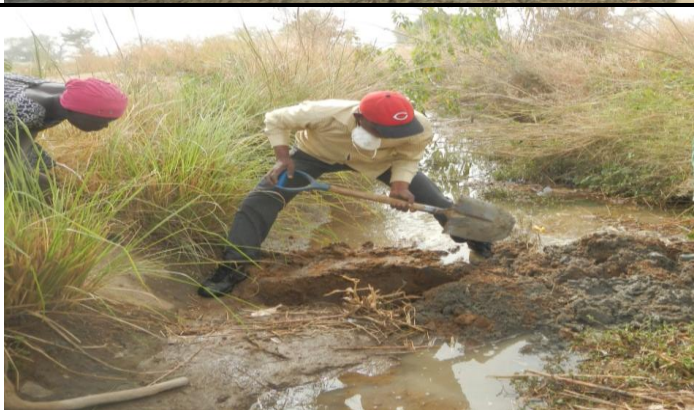
<ol style="list-style-type: none"> 1. The two main canals, with a total length of 26.5 km long had breached at several sections, silted and full of weeds and shrubs 2. The average depth of sediments in the canals was estimated to be 0.47 m 3. The estimated average volume of sediments (silt) in the canals was 20.670 m³
Doba

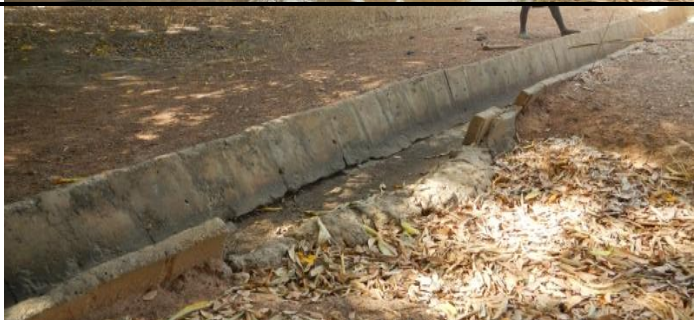
<ol style="list-style-type: none"> 1. The 0.6 km long canal had breached at several sections due to animal crossing, improper practices of farmers such as removal of slabs and water erosion 2. The average depth of sediments in the canal was estimated to be 0.15 m 3. Average volume of sediments was estimated to be 24 m³

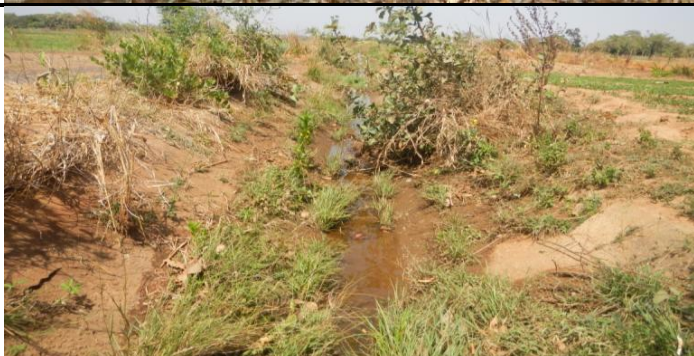
Libga

<ol style="list-style-type: none"> 1. The 1.3 km long main canal is in a poor working condition 2. It has several cracks and displaced slabs at some sections 3. It is silted, weedy and contains considerable amounts of shrubs 4. The flow length of the canal now stands at 1.15 km due to faulty construction

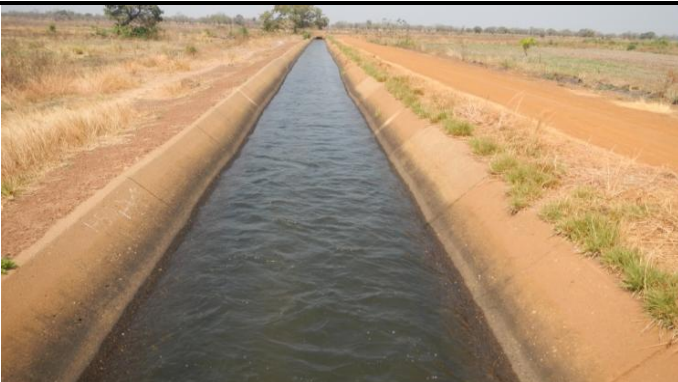
Bontanga

<ol style="list-style-type: none"> 1. The 11.5 km long canals are in good working condition 2. No breaches, sediments and weeds were found in the canals 3. The canals were rehabilitated in 2011 – 2012 by MiDA
Golinga

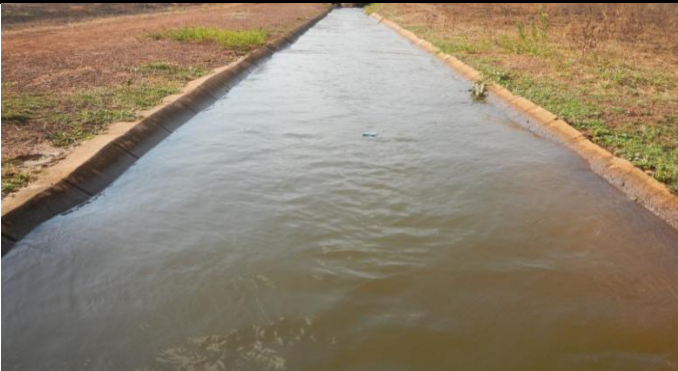
<ol style="list-style-type: none"> 1. The 2.3 km long canals are in good working condition 2. No breaches, sediments and weeds were found in the canals 3. The canals were rehabilitated in 2011 – 2012 by MiDA

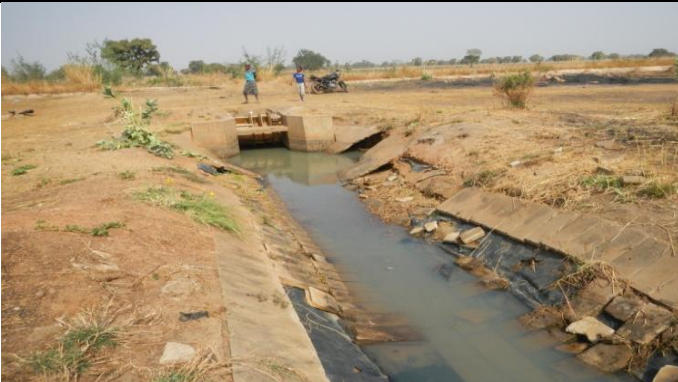
<ol style="list-style-type: none"> 1. The 82 laterals with a total length of 56 km are in poor working condition 2. They have never been rehabilitated since construction was completed in 1985 3. The concrete slabs are displaced at several sections and control gates broken 4. The present condition of the laterals results in waste of irrigation water through seepage

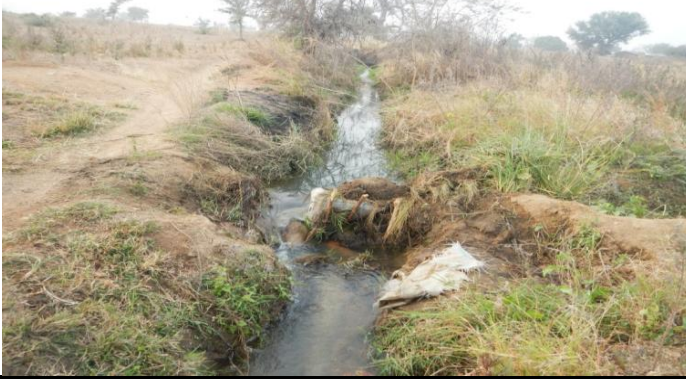
Veal

1. The 60 laterals are in poor working condition
2. They have never been rehabilitated since construction was completed in 1980
3. All the laterals have their concrete slabs, check structures and control gates removed
4. The present condition results in waste of irrigation water through seepage

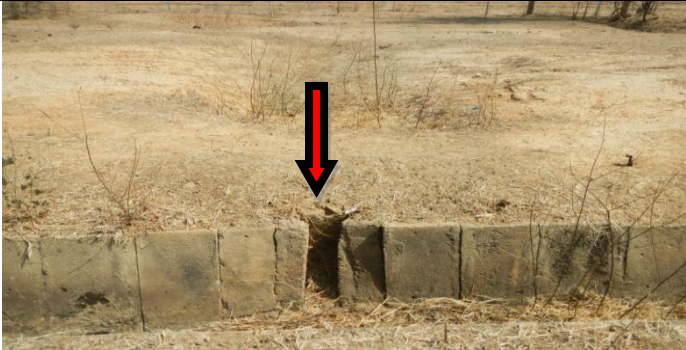
Doba

1. All the 10 laterals on the scheme are silted-up beyond recognition
2. All the lateral gates are removed
3. The arrow shows the position of a silted lateral

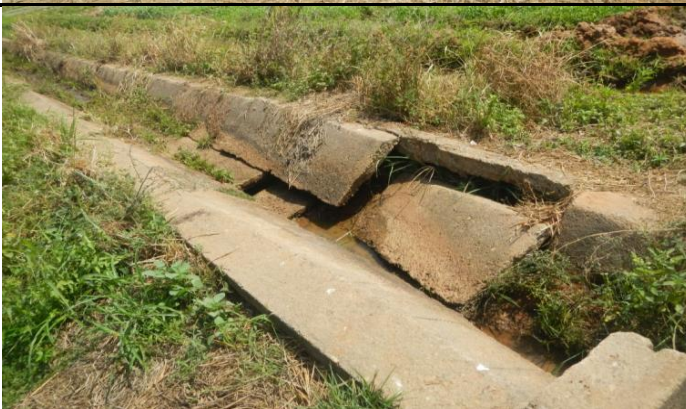
Libga

1. The 8 laterals are in poor working condition
2. Each lateral has breached at several sections despite the rehabilitation in 2008
3. Two (2) of the laterals at the tail-end are presently not functioning due to faulty construction of the main canal
4. The present condition results in seepage and waterlogging in the scheme

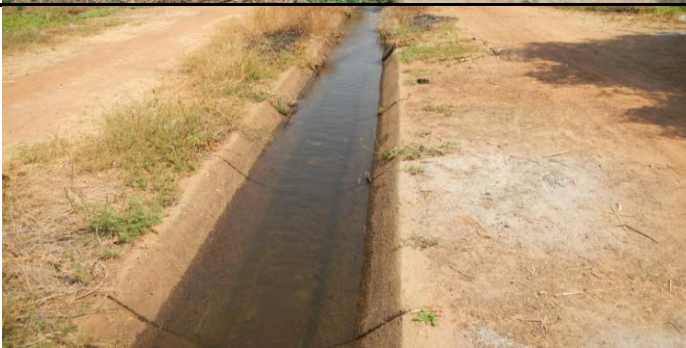
Bontanga

1. The 28 laterals are in good working condition
2. There are no breaches and they are free of sediments and weeds
3. They were rehabilitated in 2011 – 2012 by MiDA
4. The check structures are working properly

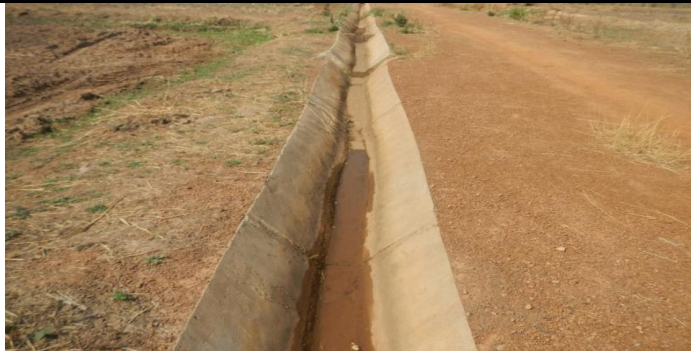
Golinga

1. All the 12 laterals are in good working condition.
2. No cracks, sediments and weeds
3. They were rehabilitated in 2011 – 2012 by MiDA
4. Some lateral and check structure gates are absent

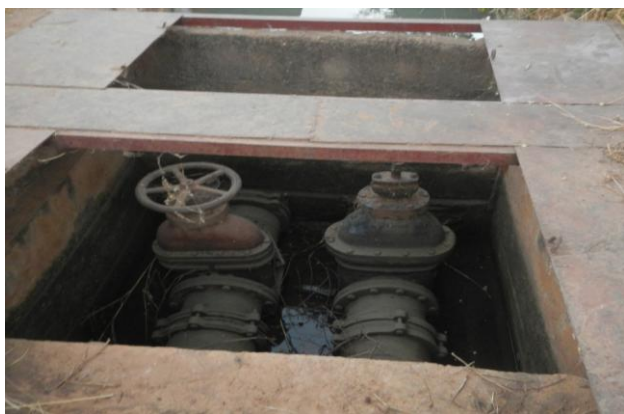
Vea Irrigation Scheme: Four (4) out of the five (5) valves installed at the headworks are not functioning due to technical problems. Presently, only one valve on the right bank canal is functioning. It discharges water at $1.26 \text{ m}^3/\text{s}$. As illustrated in Plate 5, the two (2) valves which were installed to discharge water at $1.07 \text{ m}^3/\text{s}$ on the left bank canal are defunct; hence no irrigation was carried out

Plate 5: Defunct Off-take Valves in Vea

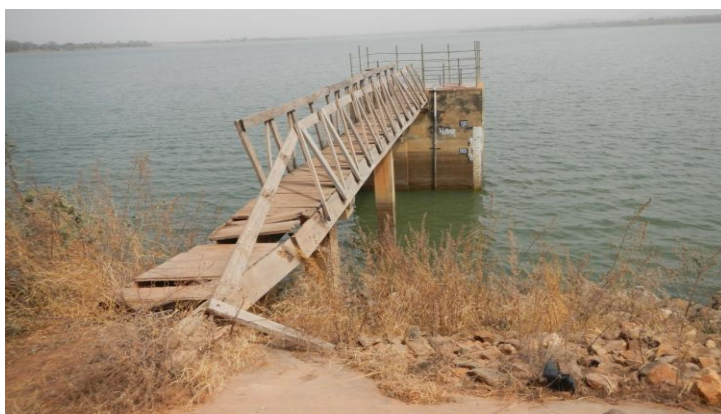
on the left bank canal irrigable area in 2015. The two (2) walkways to the off-take valves in the reservoir are in dilapidated condition (Plate 6).

Plate 6: Condition of Walk-Way to Off-take Valves in Vea

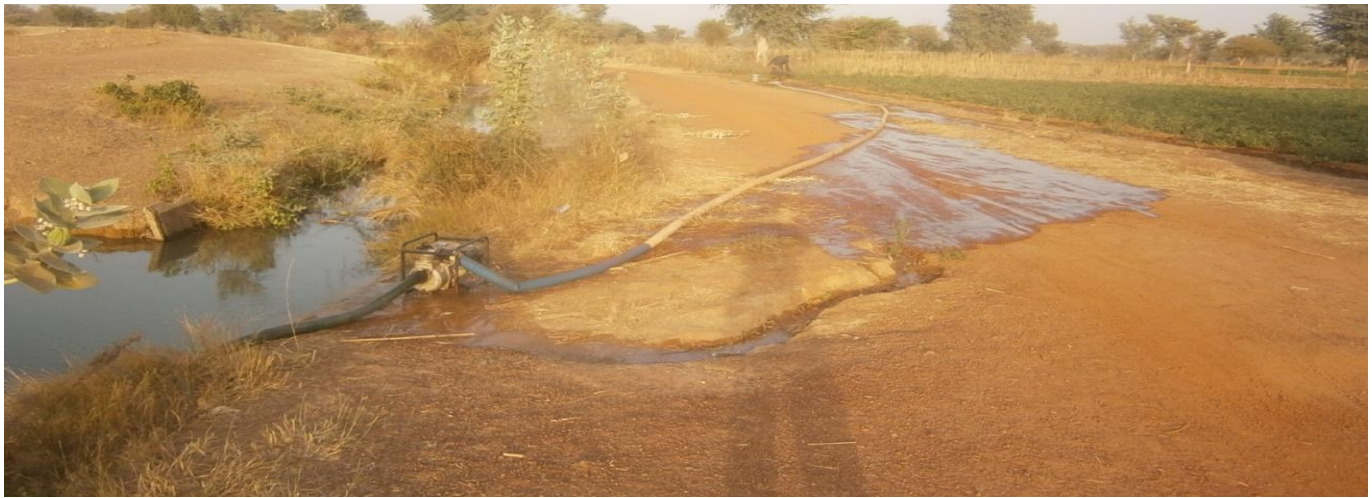
Plate 7: Lifting Water from Canal Using Water Pump in Veia Irrigation Scheme

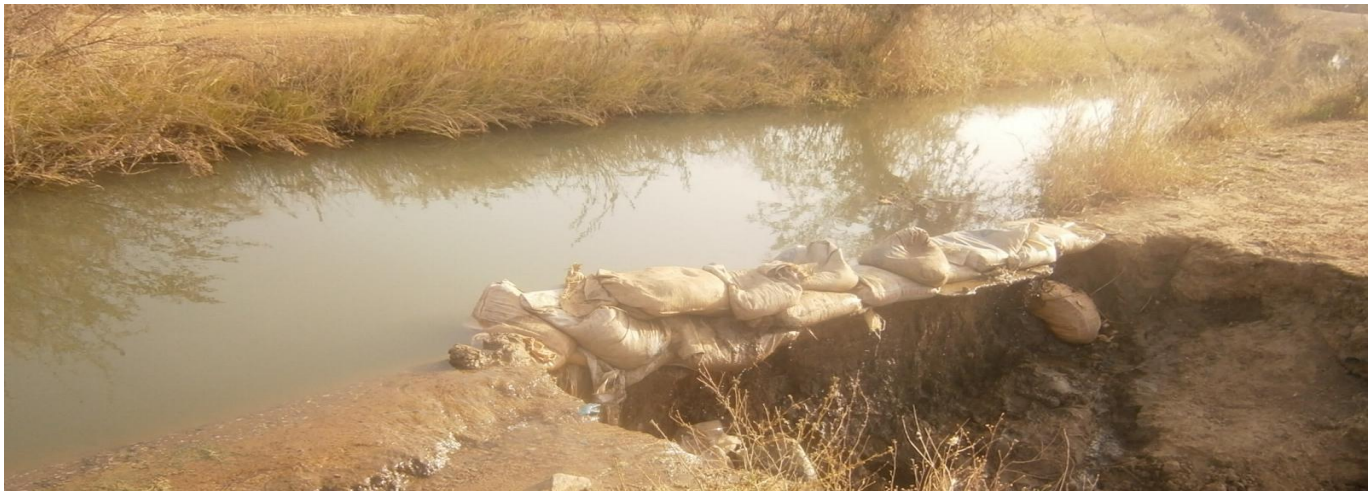
Plate 8: Breached Canal Temporarily Repaired With Sandbags by Farmers in Veia Irrigation Scheme

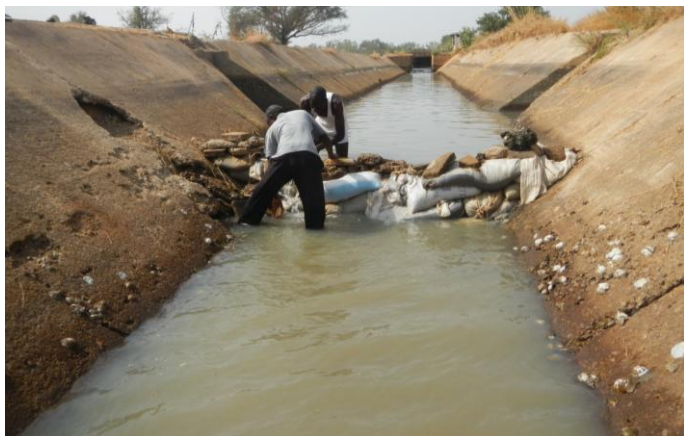
As a result of a collapsed check structure in the main canal, farmers on the lateral at the Tono scheme had to improvise a check structure using sandbags, grass and stones to control water to their fields as shown in Plate 9.

Plate 9: Farmers Improvising Check Structure on a Canal Using Sandbags and Stones in Tono Irrigation

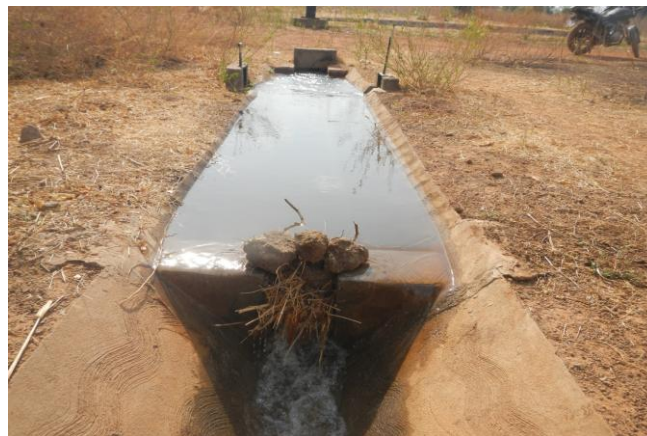
At the Golinga irrigation scheme where there were no lateral check structure gates, the affected farmers had to improvise gates using stones, mud, sandbags, grass and logs to control water into their fields (Plate 10). However, the use of sandbags, mud, stones, logs and sticks as a regulatory check structure also causes sedimentation of the canals and laterals.

Plate 10: Improvised Lateral Check Structure from Stones and Grass at Golinga Irrigation Scheme
