**THE PROVISION AND MANAGEMENT OF PUBLIC TOILETS IN WA
TOWNSHIP**

A THESIS SUBMITTED TO THE DEPARTMENT OF COMMUNITY HEALTH,
SCHOOL OF ALLIED HEALTH SCIENCES, UNIVERSITY FOR DEVELOPMENT
STUDIES IN PARTIAL FULFILLMENT OF THE REQUIREMENTS FOR THE AWARD
OF DEGREE OF MASTER OF SCIENCE IN COMMUNITY HEALTH AND
DEVELOPMENT

APRIL, 2017

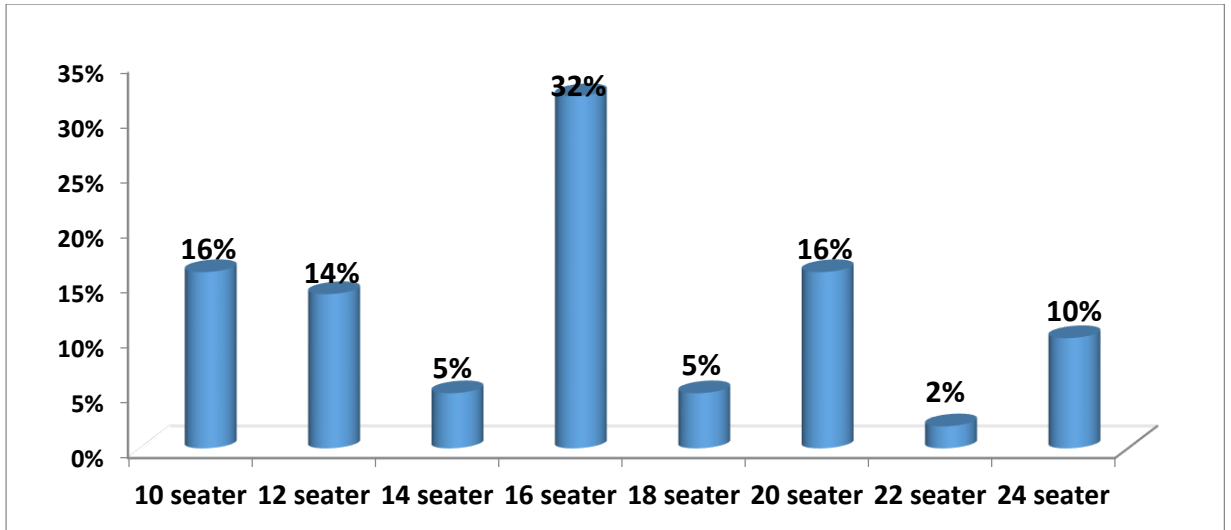
Figure 4.1: Sitting Capacity of Public Toilets

Of all the PTs in the Township, the sitting capacity ranged from 10 to 24 squat holes. The capacity of the toilets is shown by Figure 4.1 below.

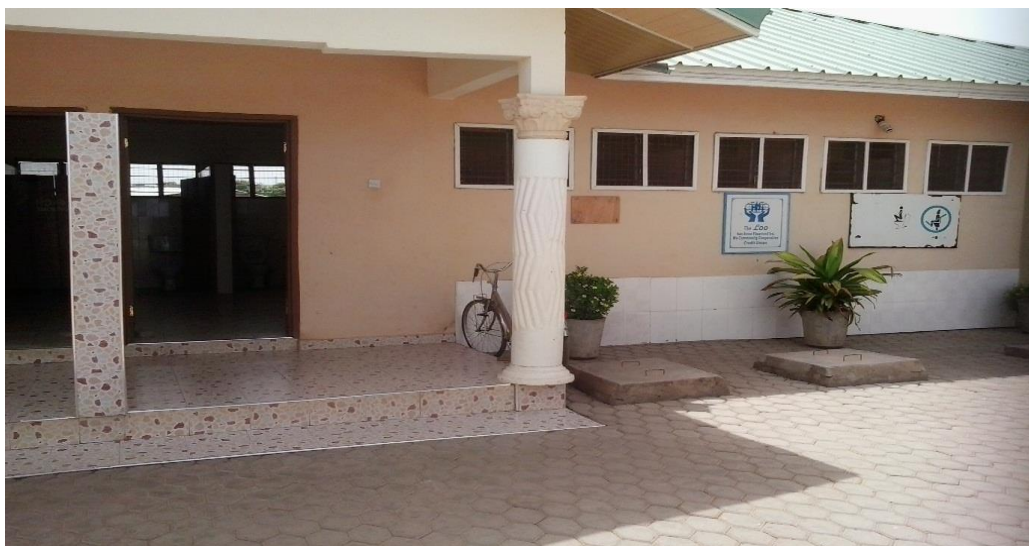
Plate 4.1: The state of a typical WC in Kpaguri Area

PTs visited were of two (2) types of designs i.e. KVIP (42 PTs) and Water Closet (WC (2). Both WCs had their water supplied from two mechanized boreholes connected to a water tank in order to provide constant water for flushing and cleaning. An interview with a toilet manger/attendant revealed that most users of the WC were not familiar with their usage. They either broke the handle or squat on it instead of sitting. Plate 4.1 below shows the state of a WC PT in the Kpaguri area.

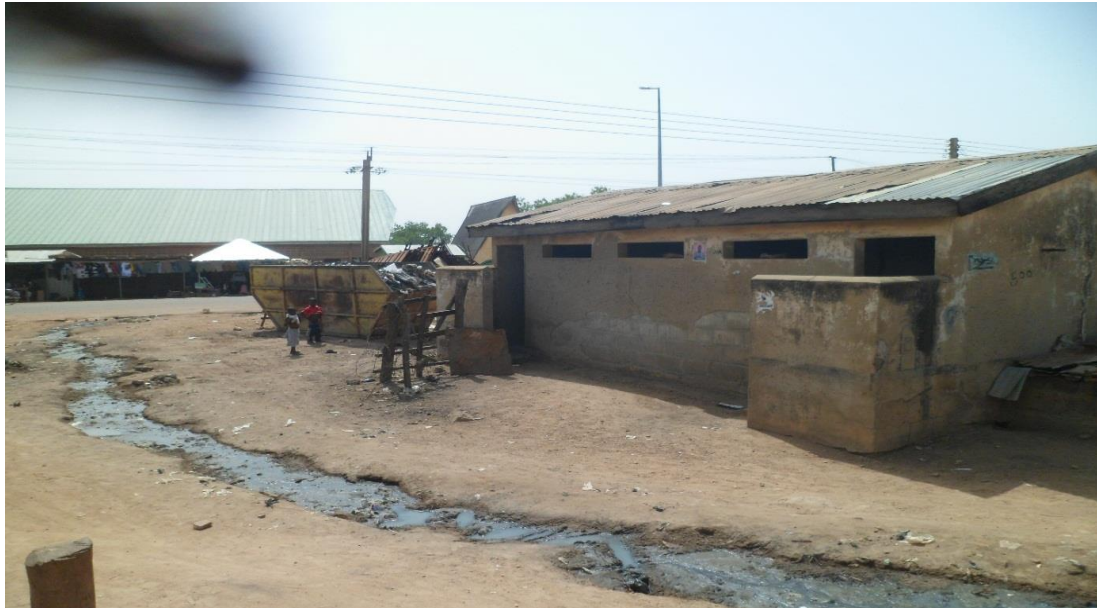
Plate 4.2. The state of a typical KVIP in Zongo area

Interviews with public toilet attendants/or managers also showed that all of them had no technical understanding of the working principle behind the KVIP technology. All of them were just concerned about cleaning the facility in the morning and hoping to make good revenue at the end of the day without paying much attention to the effective operation of the technology. The wire mesh meant to be at the tip of the vent pipes were visibly absent on observation. The doors to the cubicles and vent pipes were damaged as well. Plate 4.2 above shows the deplorable nature of a KVIP PT in the Zongo area.

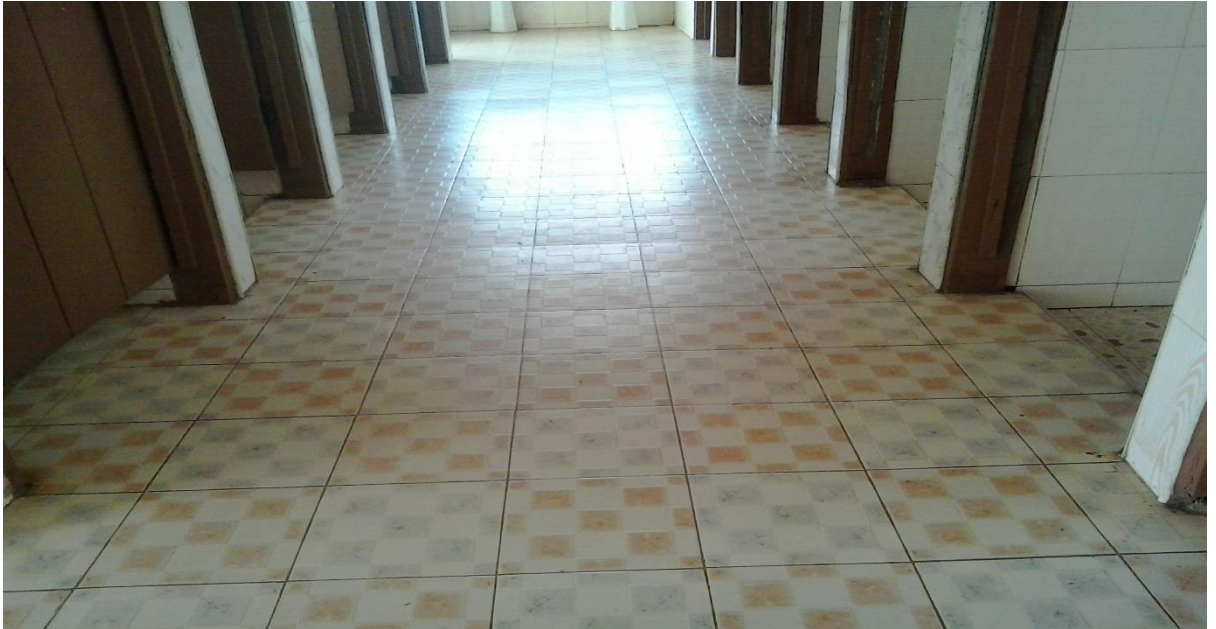
Plate 4.3; Inside of privately Owned PT located in Kpaguri Ganya area

The surroundings of the POPTs were also without litter. The sinks, tiles and toilet receptacles were neatly cleaned making the facility user-friendly as showed in Plate 4.3 above.

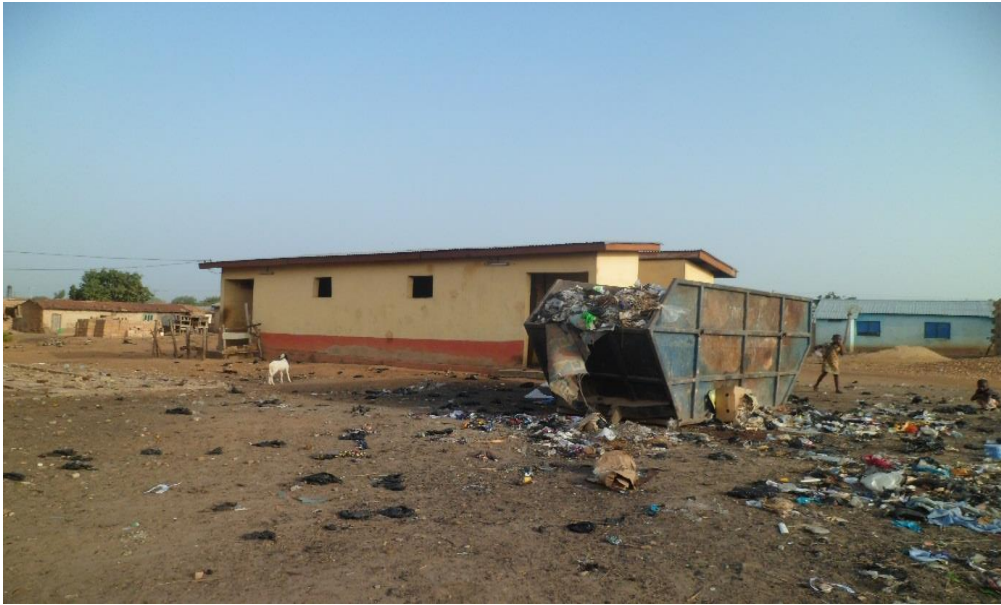
Plate 4.4; showing surroundings of a Government Owned PT in Kambale area

The GOPTs on the other hand were mostly dirty looking, their roofs worn out, the walls were broken and the doors either removed or hanging. The surrounding of 90.91% (40) of the GOPTs were engulfed with refuse and overgrown with weeds because refuse dams or over flowing refuse containers were located around these toilets. Their surroundings were littered especially with faeces as shown in plate 4.4 below.

The conditions of 70.45% (31) of the GOPTs were deplorable and can best be described as death traps. Maggots and houseflies could be seen both inside and outside these facilities. One can hardly bear the stench that emanated from these GOPTs. In many instances, male users often remove their shirts before entering the facility to reduce the scent on them after using the toilets. The POPTs employed full time cleaners, who are paid monthly unlike the GOPTs, which hired people daily to clean the facilities. Plate 4.5 above showing the clean surroundings of a POPT in Kpaguri Ganya area.

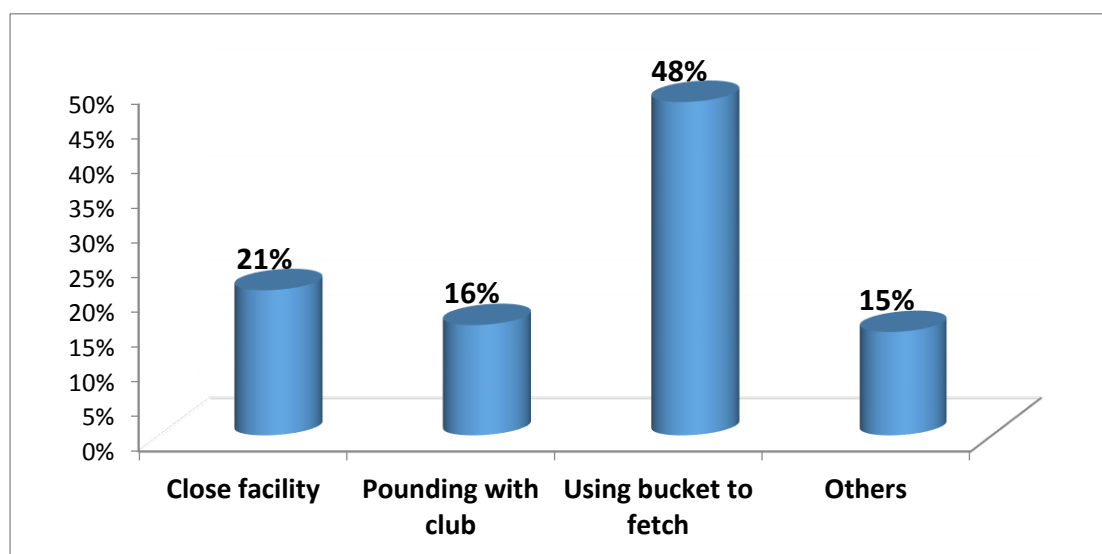
Figure 4.4: Various methods of Faecal Sludge disposal in the absence of Mechanical Cesspit Emptiers

Manual methods of draining were used when operators were not able to secure the service of a septic emptier when the facility was full to capacity. The study uncovers that 48% public toilet facilities disposed their faecal sludge by using a bucket to fetch from the septic tanks and thrown just beside the facility. Also, 21% of the respondents indicated that when the facility was full and they were unable to secure the services of the septic emptier, they usually temporarily close down the facility until such a time that they were able to dispose of the faecal sludge. The analysis further revealed that 16% of attendants used club to pound the sludge so that the dried sludge reduced to provide space for the continual usage of the facility and the rest of the 15% of

respondents resorted to manually fetching and carrying the sludge to the nearest pit they could find to dump it there.
