Siltation of the Reservoir of Veia Irrigation Dam in the Bongo District of the Upper East Region, Ghana

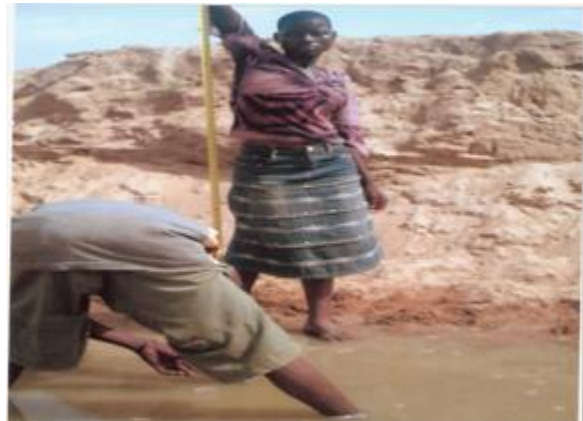
Field Measurements were done to determine the depth of sediments in the Veia reservoir. Ten soil profile pits of surface dimensions 1.2 m x 1.2 m (plate 1) were dug in the reservoir 30 m away from the water. Based on estimates of the original depth of reservoir, maximum permissible depth was 1.2 m. The soil profiles were distributed equally on both

Plate 1: Measurement of depth of sediments in a profile pit in the Veia reservoir of Ghana

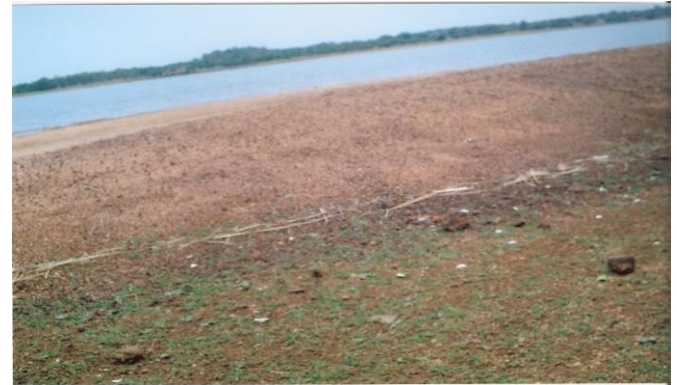
Assuming similar annual deposition for the 33 years; average yearly sedimentation of $1.4 \times 10^5 \text{ m}^3$ occurs in the reservoir. For the entire catchment area, this amounts to $1000 \text{ m}^3/\text{km}^2/\text{year}$. The estimated rate of sedimentation of the reservoir is close to the findings of [2], who described sedimentation of the Quipolly reservoir in Australia between 1941-1943 as “extraordinary” at a rate of $1140 \text{ m}^3/\text{km}^2/\text{year}$. At this rate of siltation, pragmatic measures: such as dredging, riparian protection and other reservoir protection measures must be carried out to curb the situation. Should annual deposition remain the same; there will be a reduction in lifespan of the Vea dam (Table 2).

Plate 2: Pile of sediments in the Vea reservoir 33 years after construction

From the interviews with residents and farmers, a number of factors contribute to the high volume of sediments recorded in the reservoir (plate 1 and plate 2). These include:

To enhance reservoir storage capacity and reduce siltation, trees and erosion resistant grasses should be planted as riparian protection against erosion. Generally, the Vea dam need be desilted. A regular and intensified extension educational programme for farmers in the surrounding communities about Agricultural Best Management Practices on watersheds including: conservation tillage (zero and minimum tillage), proper grazing management (rotation grazing), and undertaking farming activities further away from the reservoir, should be organized.

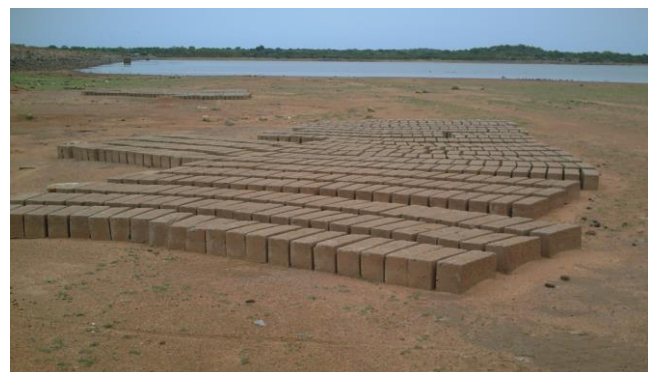
Plate 3: Building blocks made from the sand deposited in the Vea reservoir. The blocks are later carried to construction sites where they are used in the construction of buildings

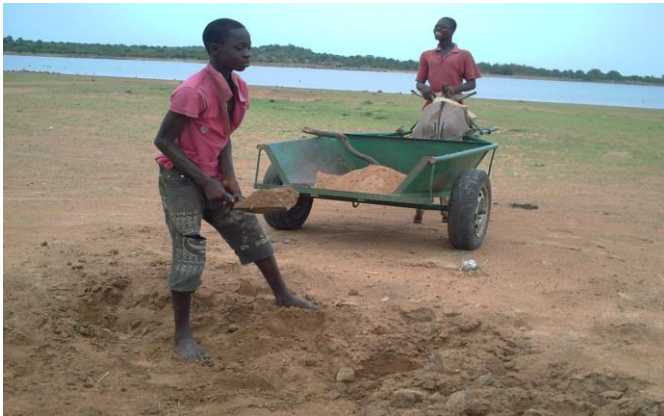
Plate 4: Sand winning in the Vea reservoir for the purposes of construction

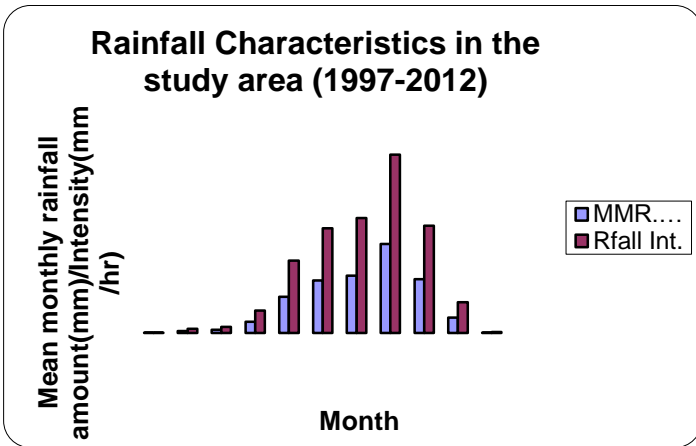
Across the catchment area, highest rainfall amounts (MMR.amt) and rainfall intensities (Rfall.Int) are generally recorded between June and September (Figure 1). These are associated with high kinetic energies that create serious runoff and erosion problems.

Figure 2: Rainfall characteristics in the study area from 1972 to 2012

The sharp, high-intensity rainfall peaks and rainfall amounts; coupled with a low infiltration rate and steep slopes enhance water accumulation that builds into runoff with high kinetic energies and erosion as explained by [9] and [8]. [8] indicated that rainstorms with intensity less than 25.40 mm/hr are not erosive but intensities greater than 25.40 mm/hr have the ability to detach soil particles and cause erosion. [9] also stated that erosion is mostly caused by rainfalls at intensities greater than 25 mm/hr. Rainfall intensities in June, July, August and September across the catchment area exceeds 25.40 mm/hr

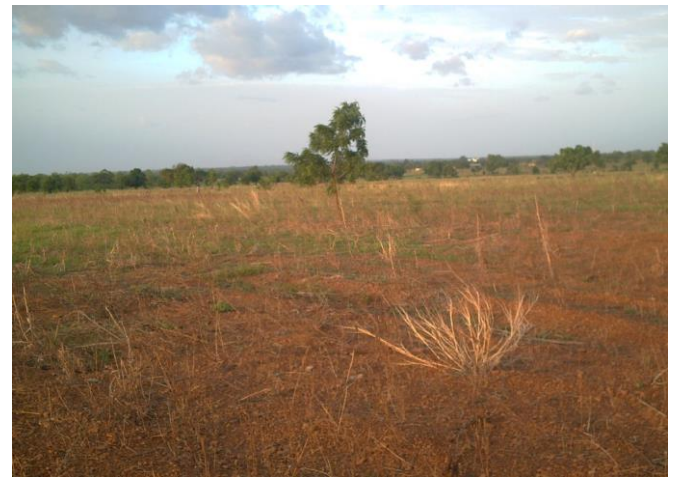
The vegetative cover within the watershed, especially tree cover is scanty and scattered as a result of the intensive farming activities across the area (Plate 5). Some plant species exists: including herbs of the family Rubiaceae (e.g., *Diodia scadens* Sw.) and Acanthaceae (e.g., *Monechma ciliatum* (Jacq.) Milne-Redhead).

Plate 5: Typical vegetative cover within the watershed of the Vea irrigation dam

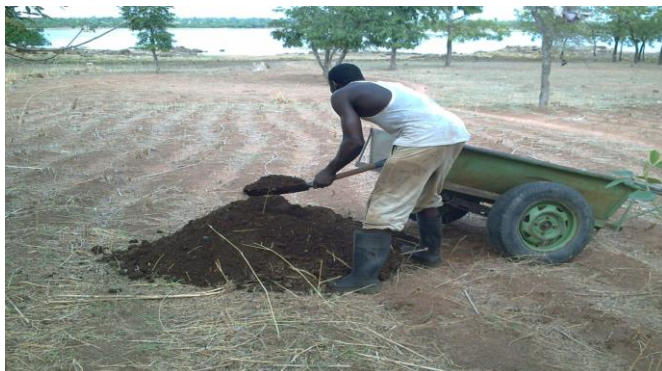
About 98% of farmers within the watershed practice conventional tillage which involves the use of mouldboard ploughs, disc ploughs and disc/tine harrows used to till the land for crop cultivation. This practice is not best for watersheds. It tends to pulverize the soil near the surface and create a compacted layer below the ploughed depth, which reduces infiltration and results in increased runoff and erosion and hence silting-up reservoirs. [9] indicated that conservation tillage such as zero tillage and minimum tillage reduce soil erosion from farmlands and are therefore best for watersheds. Besides the conventional tillage, farmers close to the reservoir ploughed along the slope instead of across the slope (plate 6). This practice enhances erosion and increase sedimentation of the reservoir.

Plate 6: Ploughing along the slope near the reservoir

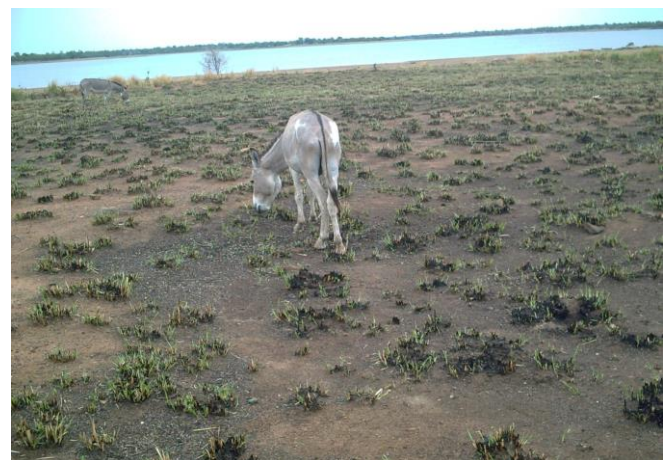
Burning was also observed within the watershed (Plate 7). Farmers burn off litter and crop residues on their farmlands, particularly during the period prior to the onset of the rainy season, as part of land preparation for planting [6].

Plate 7: Burnt riparian protection plants within the Vea watershed

This practice leaves the ground bare and renders it highly susceptible to erosion during runoff and subsequent increased sedimentation of the reservoir. Some *Panicum maximum* (vetiver grasses), which were planted as riparian protection are being burnt by the livestock keepers to make way for the regeneration of fresh foliage for their animals to graze. Burning of farmlands and forestlands can result in drastic increase in sedimentation of adjacent reservoirs. [1] estimated that, the total sediment in the Creek dam, whose catchment was burnt was 1000 times greater than it was before fire under humid tropical conditions. Such large increases in sediment load were, however, not reported after burning because of the more rapid re-growth of vegetation.
