# Assessment Of The Quality Of Water Before And After Storage In The Nyankpala Community Of The Tolon-Kumbungu District, Ghana

**ABSTRACT:**-The rationale for the study was to assess the quality of stored water in different storage facilities in the Nyankpala community in northern Ghana. The quality of treated water supplied by the Ghana Water Company Limited was also assessed before storage. Thirty households were selected based on the type of storage facility used in storing treated water. Storage facilities considered were earthen pots (EP), metallic containers (MC) and polyethylene barrel containers (PC). During the study period, a total of 120 stored water samples and four (4) tap water samples were collected and analysed over a period of four months. Generally the physico-chemical quality of treated water was well within the World Health Organizations (WHO) recommended guidelines for potability. Generally the physico-chemical quality of stored water was good since parameters measured well with WHO recommended limits. However, colour (2.5-30.0 Hz, 15.4±1.5), turbidity (2.0-15.0 NTU, 7.6±1.1) and total iron levels (<0.003-0.93 mg/L, 0.34±0.1) recorded in stored water in metall

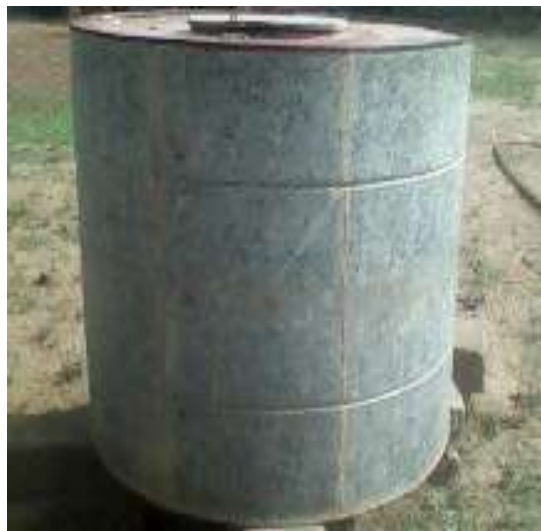
Plate 3: A metallic container (MC)

Stored water samples were collected for analysis from November, 2010 to February, 2011. During sampling efforts were made to avoid the contamination of water samples by adhering to the fundamental principles underlying the general procedures for sampling [1]. One hundred and twenty (120) samples were collected from three major storage facilities used in the community. The water storage facilities sampled from are earthen-pots (EP), metallic containers (MC) and polyethylene barrel containers (PC) (Plates 1, 2 and 3).

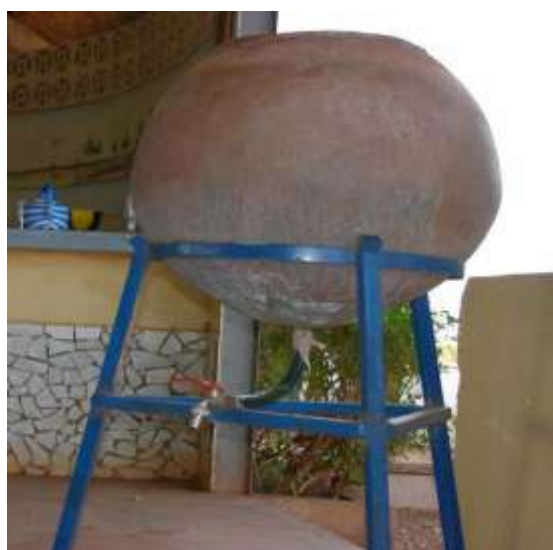
Plate 1: An earthen pot (EP) storage facility      Plate 2: A polyethylene barrel container (PC)

polyethylene tank and pot. Earthen pot showed less degree of contamination compared with polyethylene and metal tanks and this may be due to the fact that there was lower water temperature in the earthen pot than the others and also cleaning frequency was regular. Contamination levels of stored water are generally low where containers are well protected from water handling, such as with the tap and also the presence of a lid may offer some additional protection [6], [2].

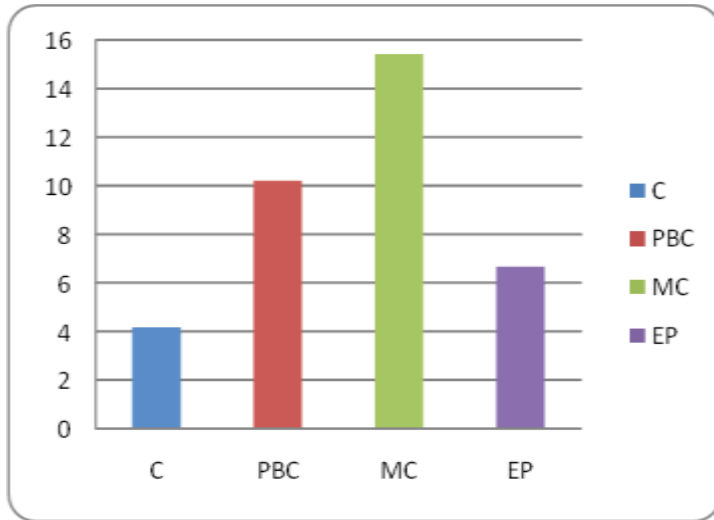
Fig.1. Mean Colour (COL) in main tap and storage facilities

The study found that generally physico-chemical parameters of stored water measured were well within the WHO recommended limits, though they were higher than that of tap water. However, the physico-chemical parameters of stored water exhibited variations, but chemically, the water was potable for consumption, except in some cases where turbidity, colour and total iron levels were higher than WHO recommended values. Water from PBC and MC recorded higher levels of colour and turbidity (fig. 1 and 2). Increased colour and turbidity levels have undesirable effect on the aesthetic quality of the water. Turbidity measurements give an indication of the concentration of suspended clay, silt, organic matter, inorganic matter, plankton and other microscopic organisms in a water source [5]. High turbidity values are associated with the survival of microorganisms due to association of the microorganisms with particulate matter in the water [5]. High levels of colour in these facilities could be a result of rust deposits inside storage facility. Turbidity and iron present in higher amounts can also cause a rise in colour level (Fig. 2 and 3). These can be dislodged if there is a change of water at storage. Though water from the main tap recorded no coliform bacteria growth, almost all of household storage water samples analyzed contained coliform bacteria (fig.4 and 5). The presence of coliform bacteria in stored water most probably originated from unhygienic water-handling practices (i.e. unsanitary use of utensils and hands touching the water). This is in agreement with earlier studies conducted by Patel and Isaacson [9], Sutton and Mubiana [14] and Sobsey[13] who indicated that the geometric design of household water-storage containers played an important role in ensuring that the stored drinking water does not become contaminated by external factors such as dirty hands and utensils. This result also agrees with other studies carried out by Pinfold [10] who found that the most common route of contamination of stored water or the presence of coliform bacteria in stored water is through water handling such as dipping. So when water samples are taken by this process, the water might be disturbed and the settled materials suspend and get into the sampled water. Usually contamination occurs when water is regularly obtained by using a 'dipper' (often a plastic/metal bowl or gourd). Hands are in regular contact

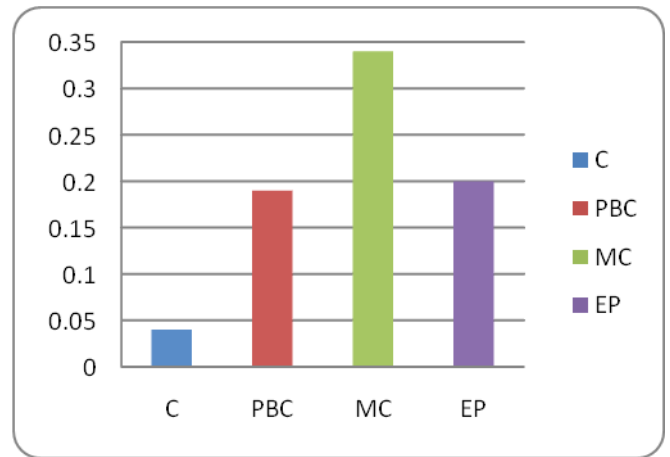
Fig.3. Mean Total iron (Fe) in main tap and storage facilities
